CUSTOMER NOTIFICATION

Title VolumePro 1000 with 512 MB Jumper Configuration.

Product	Part Number	Description
VolumePro 1000	02-0020	VolumePro 1000 board with 512 MB memory

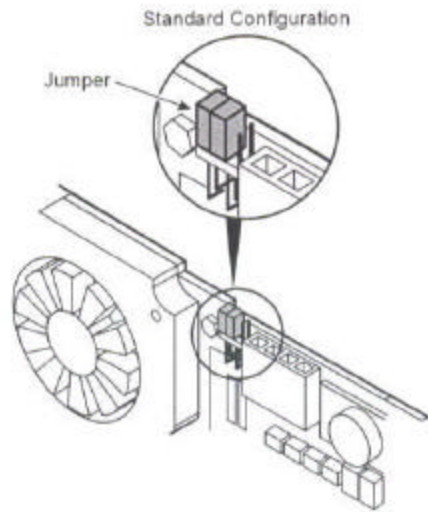
We have recently discovered a possible issue with shipped VolumePro 1000 with 512 MB boards. Boards may have been shipped from the factory with an incorrect JP1 jumper setting. The correct number of jumpers and jumper installation locations are shown below. The jumper can be found on the front top edge of the board between the fans and one of the power input plugs. These jumpers are provided to allow flexibility in system configuration. The standard two jumper installation shown is best for most applications.

Missing jumpers or jumpers installed at incorrect locations may cause unstable system behavior such as:

- Board/driver not starting
- Board works fine, then suddenly does not response after re-boot
- System does not boot

Please inspect your board to verify it has the correct jumper setting.

If the board jumper settings are wrong, please correct per the above diagram.

- install needed jumper if you have it
- contact us and we will ship you any you may need. Please provide an appropriate address for us to immediately send the jumpers to. Please send your request to the above contact person.
